LOAD TESTS OF A WOOD FLOOR OVER A BASEMENT

FINAL REPORT

FEMA Contract DCPA01-78-C-0223

June 1980

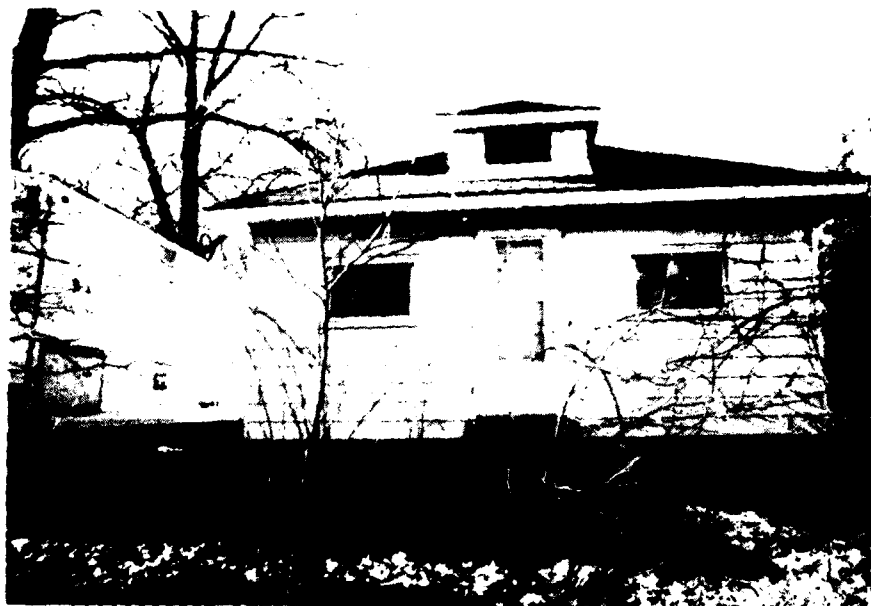
Figure 1. Front of Test Building

The test structure (Figure 1 and 2) was acquired from the Department of the Interior, Indiana Dunes National Lake Shore. This was one of several buildings in the area slated for demolition and was furnished to IIT Research Institute (IITRI) for the test program. Building selection was influenced by test requirements and availability within the time constraints of this study. Ideally, the test structure would be of "typical" construction for a single-family residential dwelling in this geographic area. A wood joist floor over a full basement was an essential requirement. Wood joists, girder and columns of "typical" size, span and spacing was also a requirement. Practical considerations included manageable size to facilitate manual loading, and reasonable access for truck traffic and the instrumentation van.

The building selected for the test had many of the desirable characteristics. It was a relatively small, single-family dwelling with a wood joist floor over a full basement. Inside dimensions of the basement in plan were 34 ft 7- $\frac{1}{2}$  inch x 18 ft 5- $\frac{1}{2}$  inch, see Figure 3. The clear height, top of basement floor slab to bottom of joist was 6 ft 10 inch. Up to about joist 14 from the north end of the building, see Figure 4, the floor consisted of 1-inch-thick and 3-inch-wide tongue and groove boards. Beyond, about joist 14 the floor consisted of 2 inch tongue and groove flooring, i.e., two layers of 1 inch boards, 3 inch wide. The bottom layer was nailed to the joists using 8d nails. The top layer in turn, was nailed to the bottom layer using 6d nails. The joist arrangement is shown in Figure 4. Joists were 2 x 6 inch with a mean center to center spacing of 24.12 inch. The joists were supported by the longitudinal, concrete block basement walls and a timber girder running parallel to these walls. The girder was in turn supported on three concrete block columns, one steel column, and the transverse basement walls. Column 2, see Figure 4, did not exist in the original construction. The species of the material was identified (Ref 4) as jack pine. The building

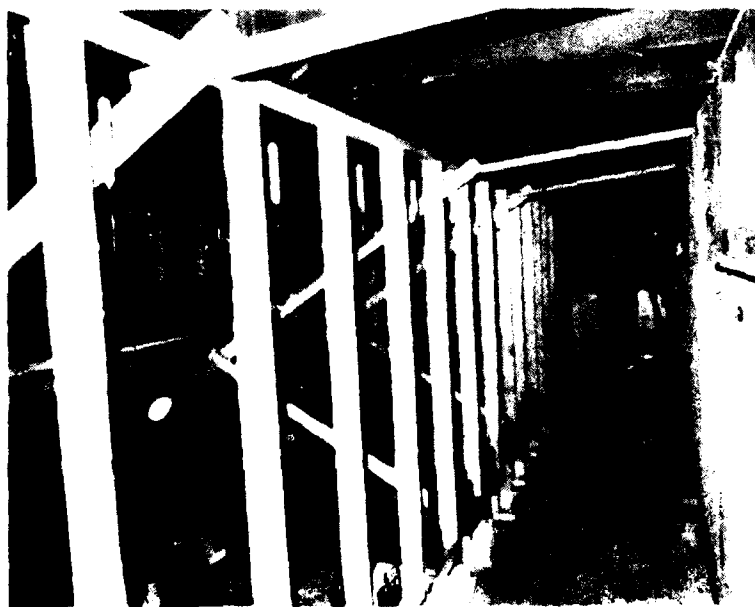
Figure 7. Studwall Catcher Showing Location of Potentiometers and Scales Attached to Potentiometer Suspension Wires

Plastic tape rules were attached as shown in Figure 7.

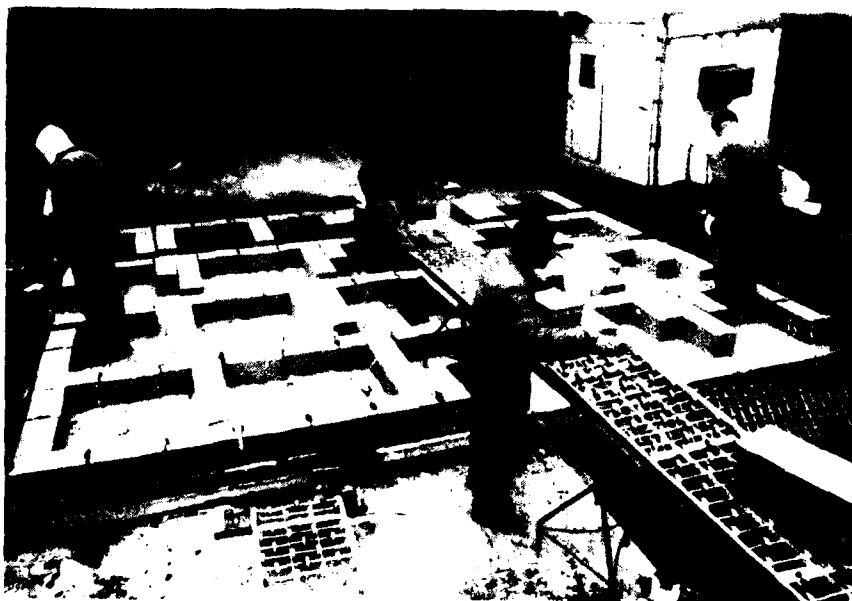
Figure 24. Start of Loading, Second Load Test

The loading sequence of the test structure is shown in Figures 24, 25, 26, and 27. Figure 24 shows the initial loading with the random distribution of the block and the method for conveying the block to the test structure.
